API-653 In-Service, Internal Inspection Report

Northeast Generation Services
South Meadow Jet Station
Hartford, CT

Tank 6
Jet-A Tank

InTANK, LLC
Project No. NU-2009-1 Rev. 00

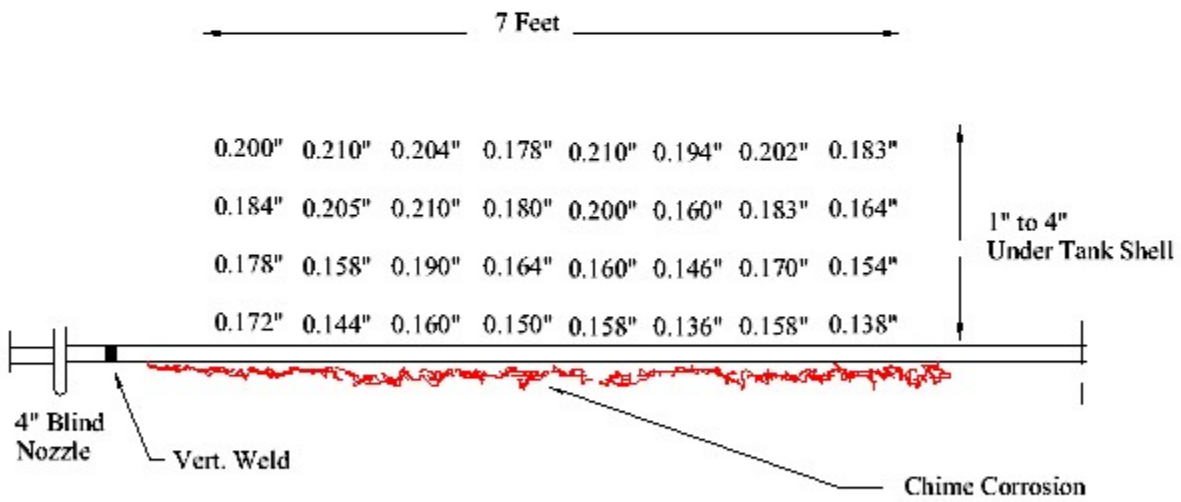
The thickness readings ranged from 0.136" to 0.210" in the nominal 5/16" (0.3125") plate indicating significant corrosion in this area of the tank bottom. The most severe metal loss was found closest to the tank perimeter.

External UT on Tank Bottom
 in Area of West Chime Corrosion
 Area Excivated Under Shell

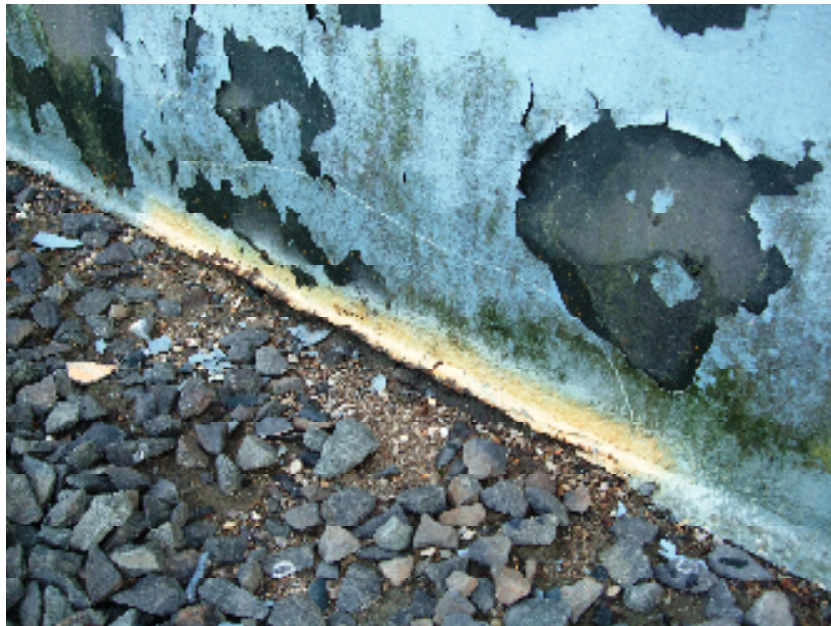
During the week of August 17, 2009, InTANK, LLC completed an inspection on Tank 6, the main Jet Fuel storage tank located at the Connecticut Resources Recovery Authority's (CRRA), South Meadow facility in Hartford, CT, operated by Northeast Generation Services Company (NGS). The purpose of the inspection was to assist in the evaluation of external, chime¹ / bottom plate corrosion that was identified during a recent external inspection. The most severe corrosion was found on the chime along a 7-foot section on the west side of the tank.

In 2009, an external inspection completed by a third party observed significant corrosion on the tank bottom chime. The most severe corrosion appeared to be on the west side of the tank (see photos in Appendix B).

Photo 2: Area of Most Severe Chime Corrosion (west side of tank)

Given the difficulty in predicting exact corrosion rates and given the age of Tank 6, it is our recommendation that the tank be removed from service within 2 years from this date (removed from service no later than August 2011). The tank could be inspected and repaired at that time if desired.

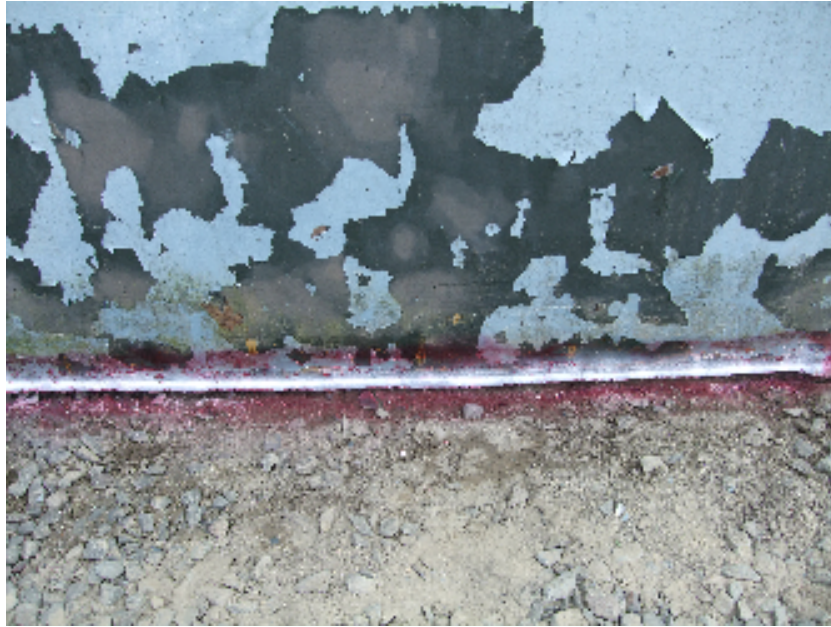
The results of the PT inspection were negative with no linear indications seen. At this time, it appears that the metal loss to the external corner weld has not caused any distortion or cracking.

Photo 3: Results of Dye Penetrant Examination (Note absence of linear indications)

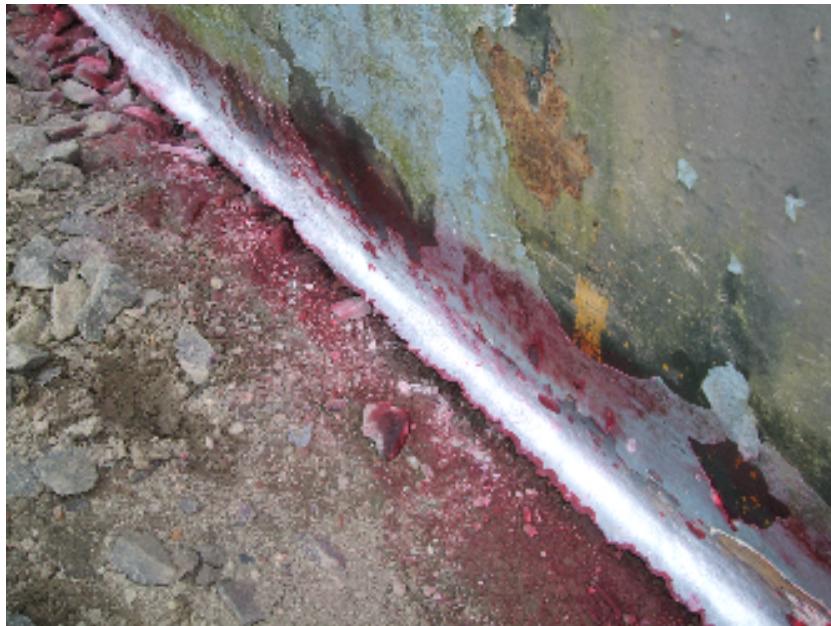
Photo 4: Close-up View of Dye Penetrant Inspection

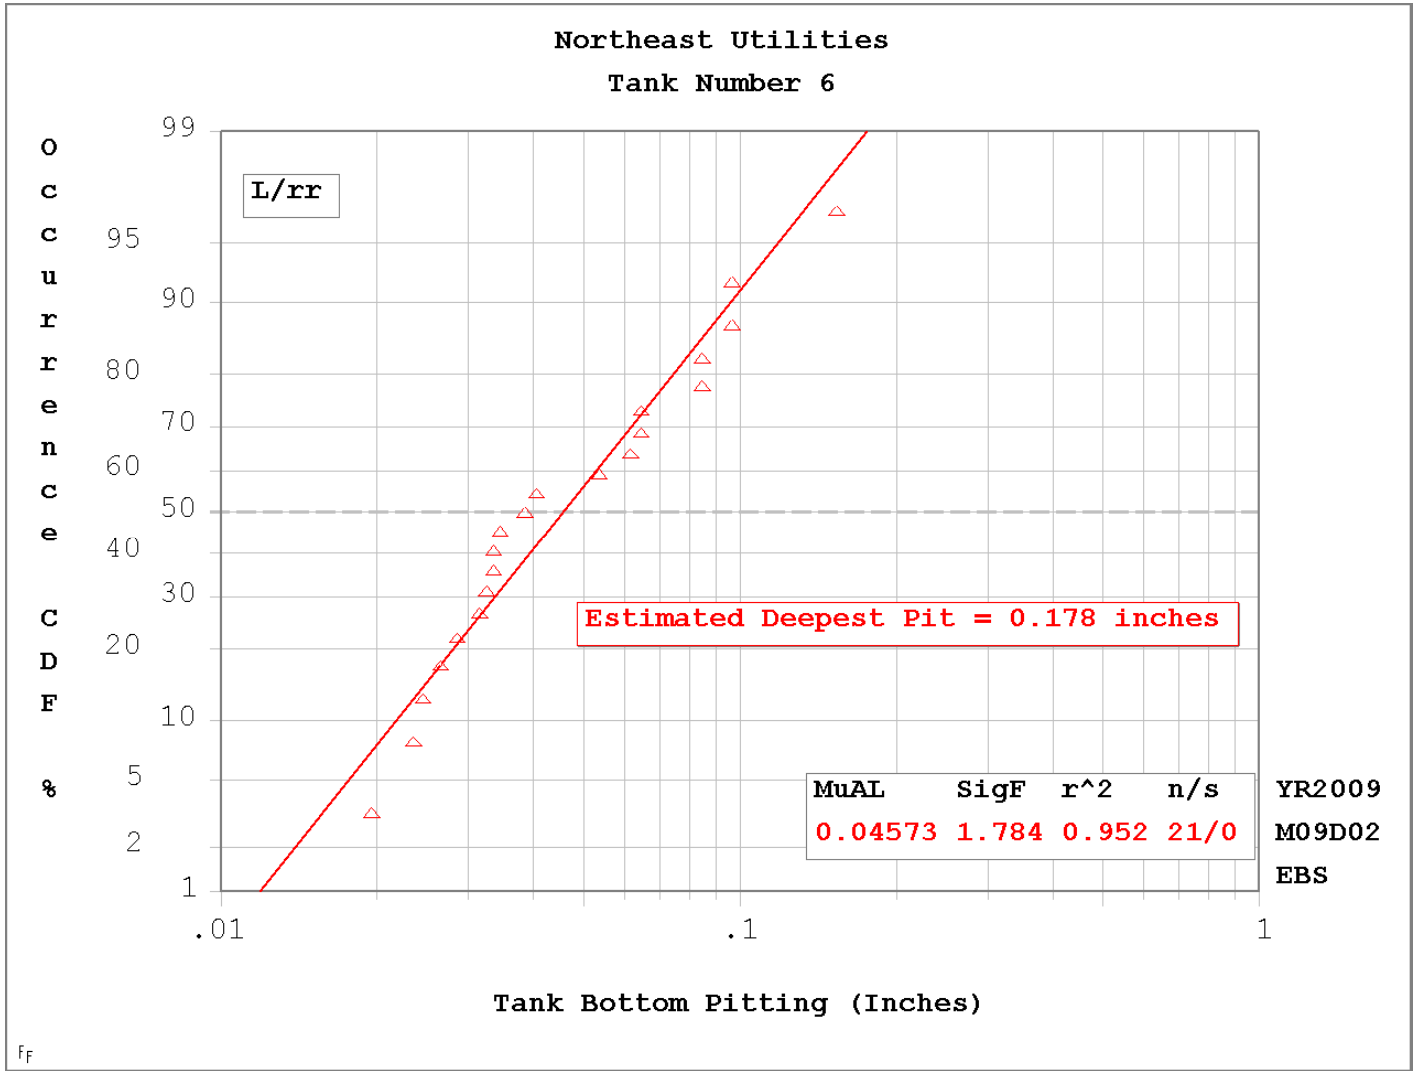
Extreme Value Analysis (EVA) Plot

Based on the data collected from the perimeter of Tank 6, our EVA predicted that the minimum thickness in the sketch plates would equate to 0.135” using a confidence factor of 95.2%.

Please note that the EVA minimum of 0.135” is almost identical to the minimum thickness of 0.136” found during the manual, under tank inspection.
