**REPORT ON PROGRESS OF  
CAPITAL IMPROVEMENT PLAN  
AT THE MID-CONNECTICUT  
WASTE PROCESSING FACILITY**

**Connecticut Resources Recovery Authority  
100 Constitution Plaza  
Hartford, CT 06103**

**Grillo Engineering Company  
9 Ash Street, P.O. Box 479  
Hollis, NH 03049-0479  
(603)465-3111**

**January 24, 2008**

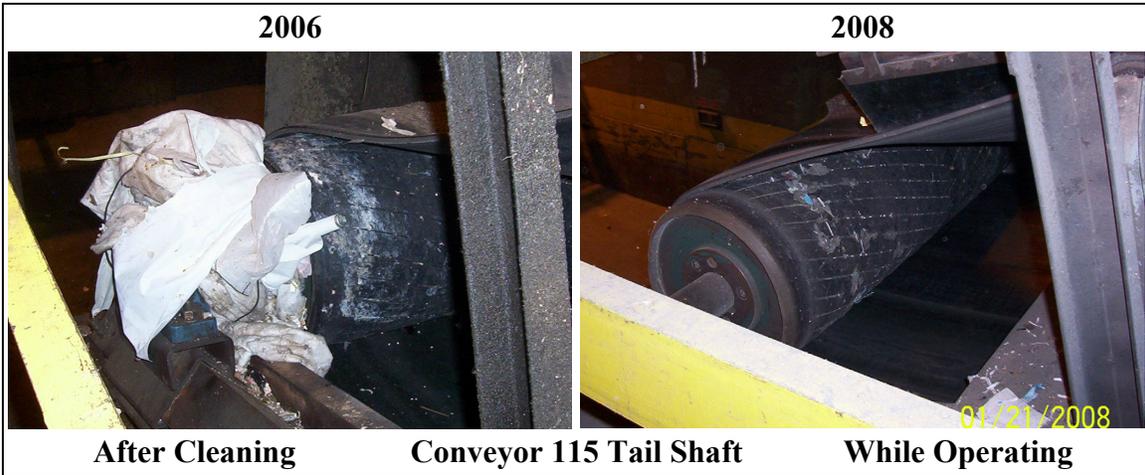
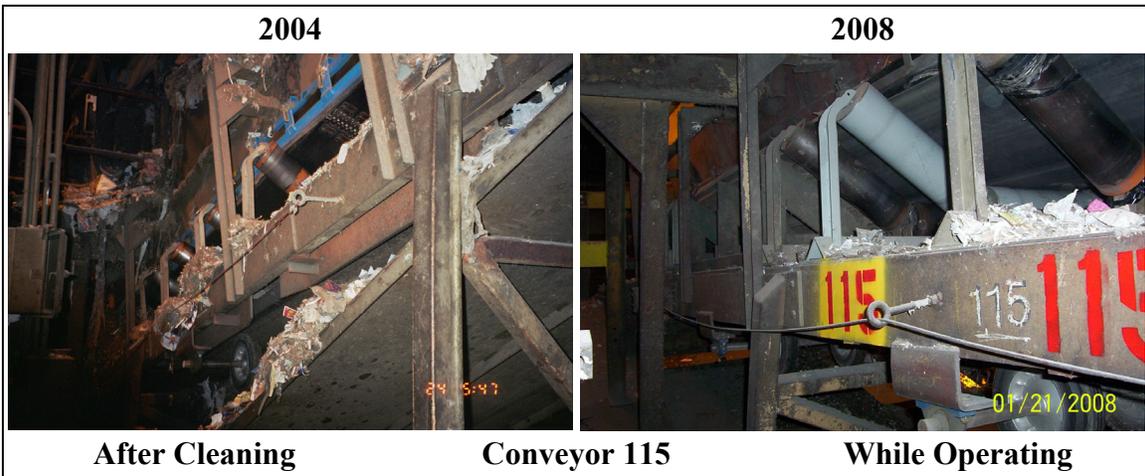
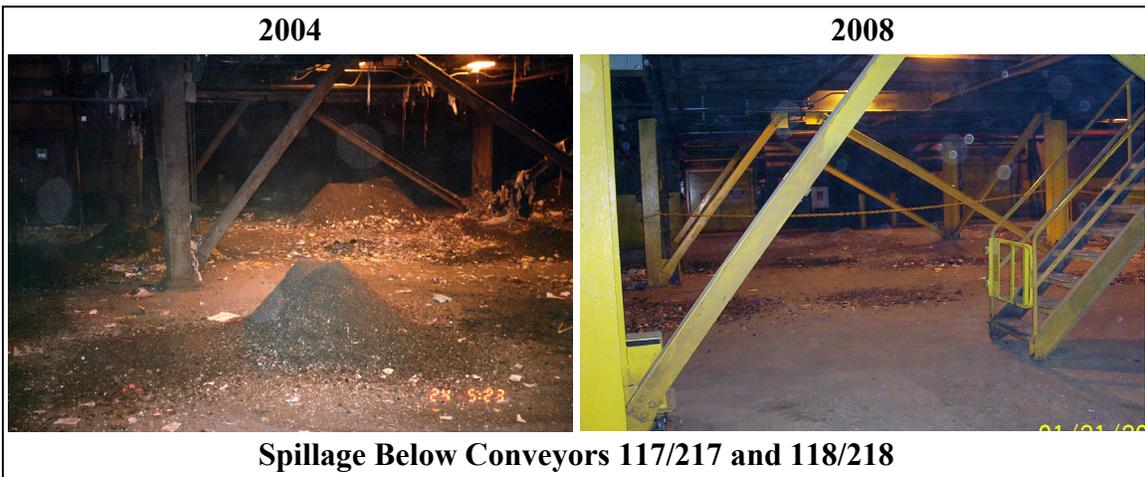
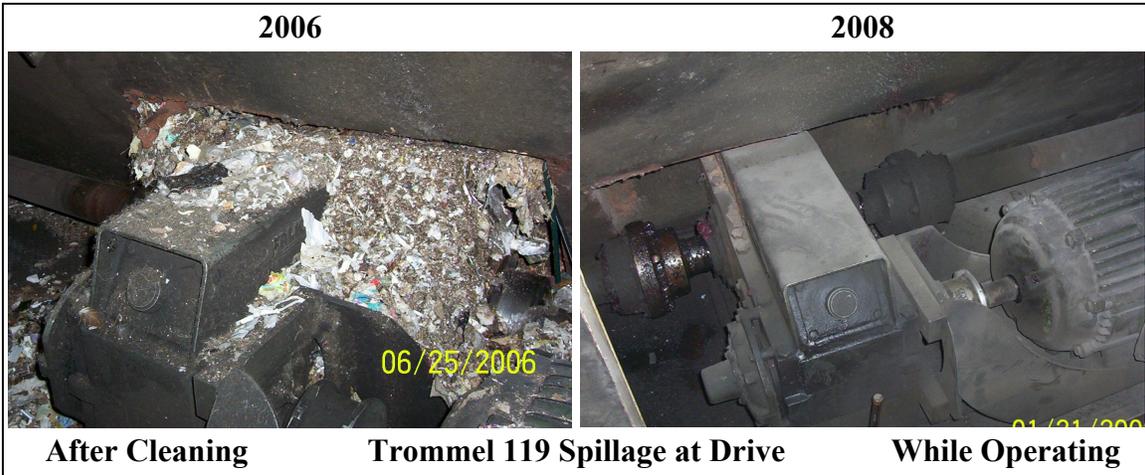
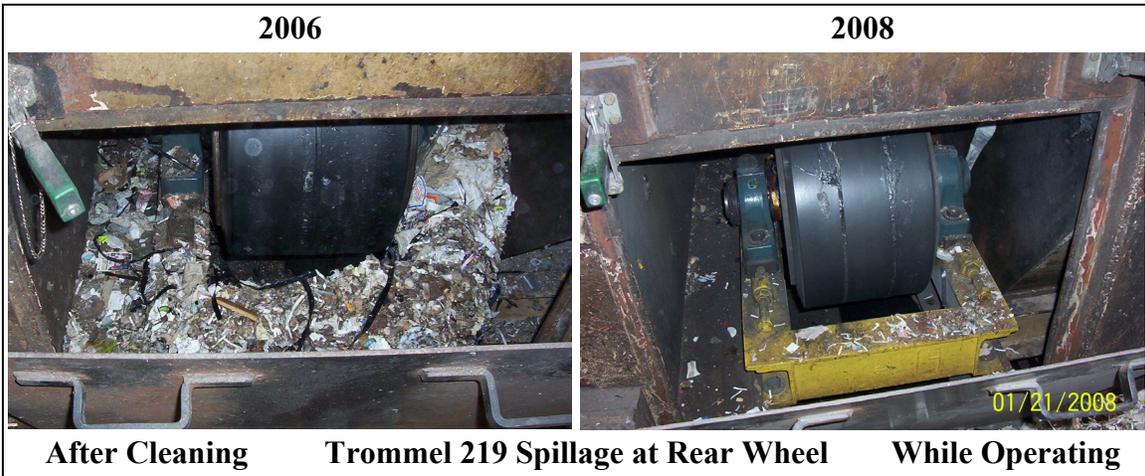
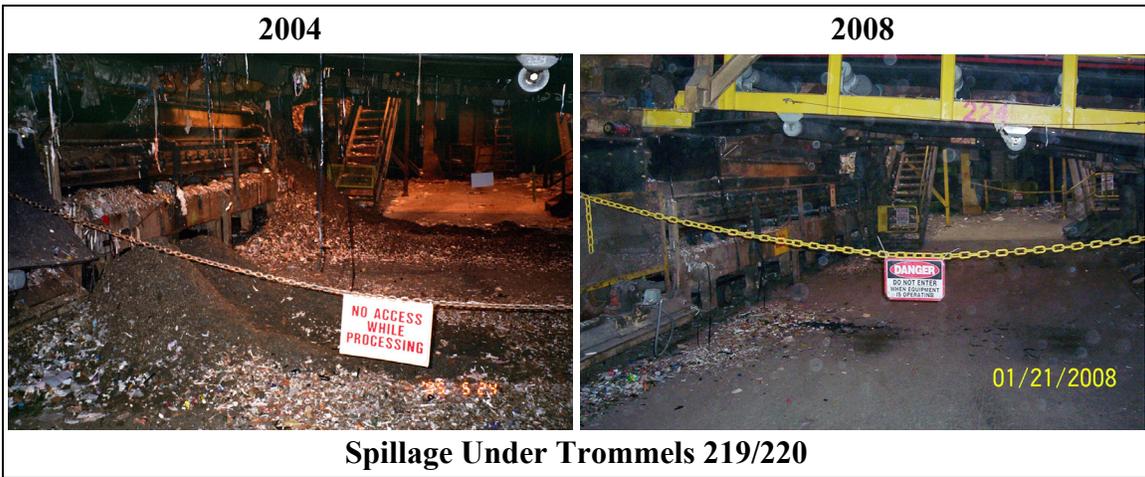
Photos were taken during site visits in 2004 and in preparation of the 2006 report. Photos of the same areas were taken as part of the preparation of this report. Both sets of photos, showing "before" and "after" conditions for comparison are at the end of this report. In each case, the "before" photo is on the left. Every attempt was made to duplicate the position of the earlier photo so a direct comparison can be made.

In some cases, the "before" photos are labeled "after cleaning". These were taken immediately before startup on one day in 2004. The equipment had been cleaned after operations concluded on the prior night. Some of the "after" photos are labeled "while operating". These were taken after approximately seven hours of operation while the equipment was running. The 130 and 230 conveyors had to be shut down for safety reasons to obtain the photos taken from the area near the secondary shredder.

The photos of Conveyor 100B contain notation "original wheels" and "rebuilt blocks". The conveyor originally had steel wheels to carry the conveyor pans. The conveyor was rebuilt with urethane blocks that wear better and are substantially less expensive to purchase and maintain.

The photos of Conveyor 124 contains the notation "original" and "rebuilt". Conveyors 124, 224, 125, and 225 are under the primary trommels and perform the same functions. All four were

similar in appearance to the "original" photo of 124. All have been rebuilt and are now similar in appearance to the "rebuilt" photo.

The photos show the significant improvement in overall cleanliness of the facility, which impacts operations and maintenance directly. The improvement is attributable to the implementation of the capital improvement plan and the new maintenance policy.
